## Prüfbericht Test Certificate

<b>Prüfgegenstand // Object:</b>	Temperature stress test of All Sky Imager ASI-16.
<b>Auftraggeber // Customer:</b>	CMS Ing. Dr. Schreder GmbH Lofererstraße 32, A-6322 Kirnbichl AUSTRIA
<b>Hersteller // Manufacturer:</b>	CMS Ing. Dr. Schreder GmbH
<b>Typ // Type:</b>	ASI-16
<b>Seriennummer // Serial number:</b>	16015
<b>Datum // Date:</b>	15. June 2016 - 19. June 2016
<b>Seitenanzahl // Number of pages:</b>	4

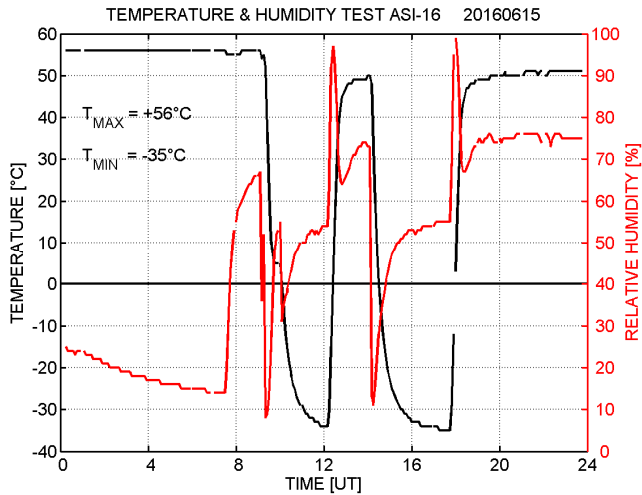
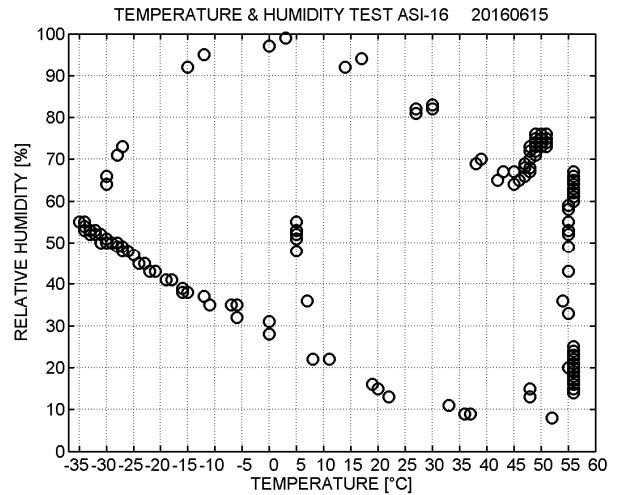
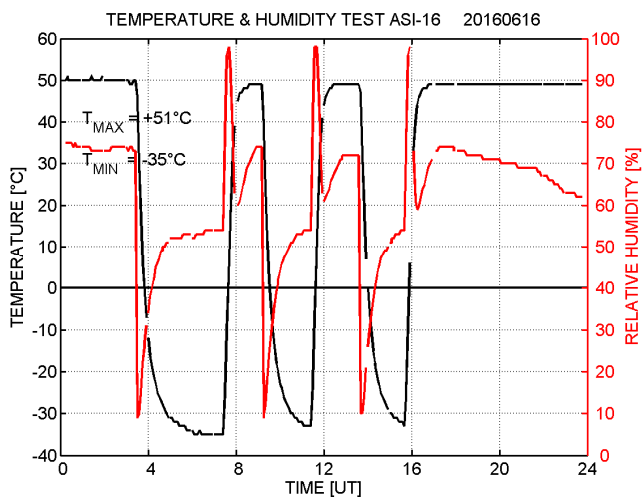
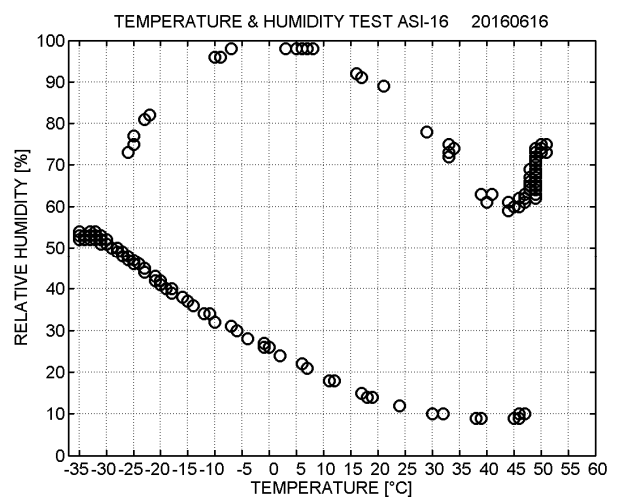
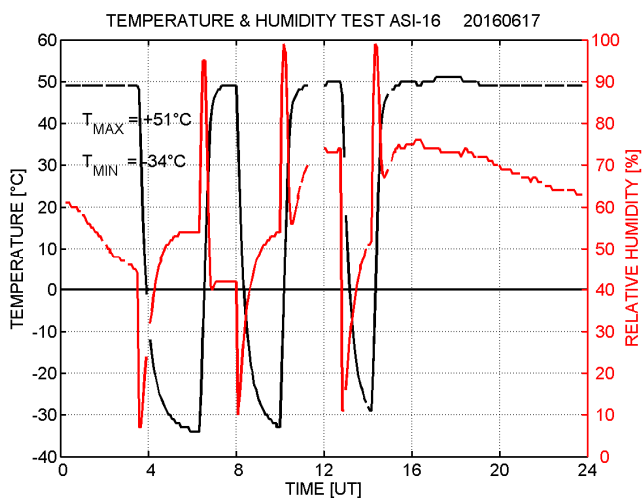
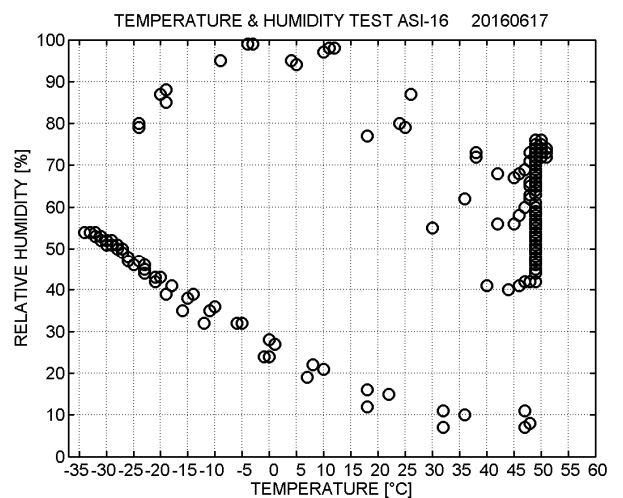
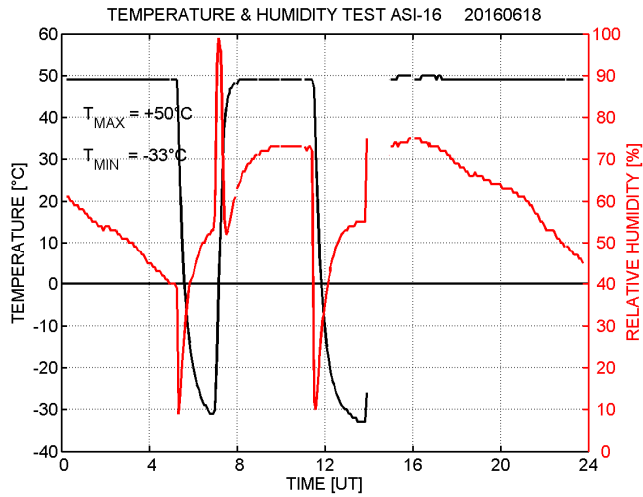
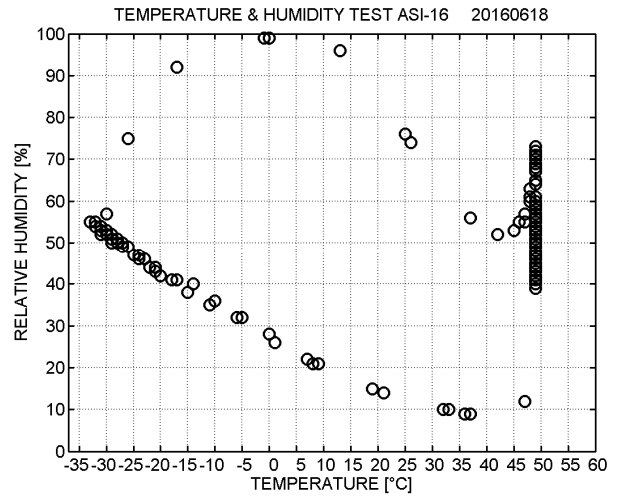
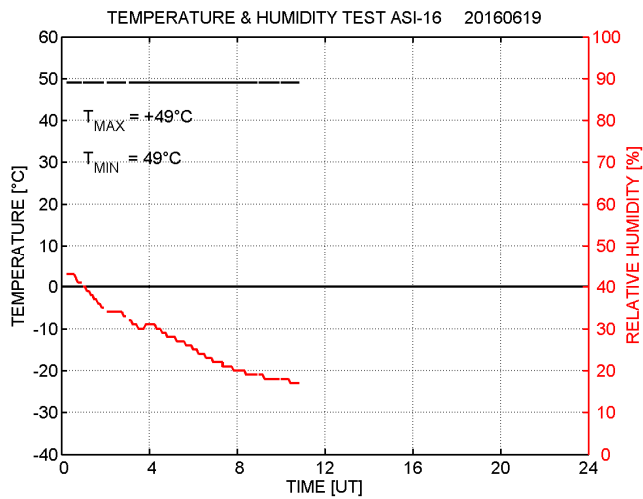
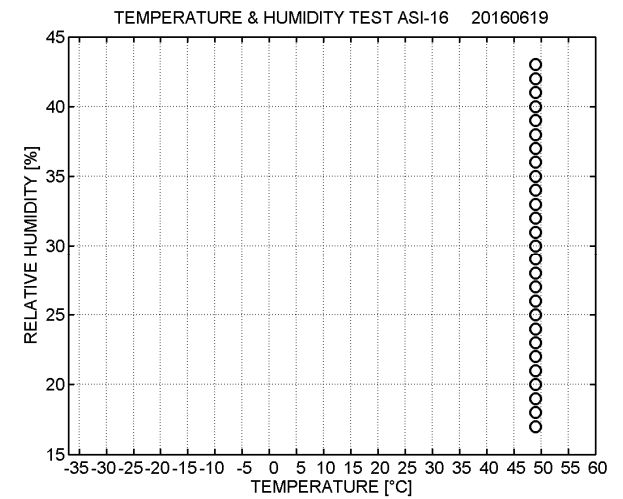
The All Sky Imager was successfully tested for standard operation modus under "Temperature stress scenario" between  $T_{ENV} = -35^{\circ}\text{C}$  and  $T_{ENV} = +56^{\circ}\text{C}$ , with a measurement and climate chamber control tolerance of  $\pm 3^{\circ}\text{C}$ . In total 10 stress cycles were carried out within 4 days. The system was running under all tested environmental situations without troubles – 2 images @ 5 minutes were taken without loss of image data. The temperature and humidity measurements are presented in the plots below.

Test cycles were started on day 20160615 and lasts over 4 days until 20160619. 10 stress cycles were carried out. Starting at an environmental temperature  $T_{ENV}$  of +56°C the temperature cycles were set to  $T_{ENV}$  lower -30°C and higher +45°C. The lowest  $T_{ENV}$  was -35°C. Additional the relative humidity inside the test chamber was logged. ASI was running as required.
